## Chapter 3

### Methodology

#### - Descriptive Analysis to define the Historical Values and Outstanding Architectural Characteristics of *Tu Giac* Houses -

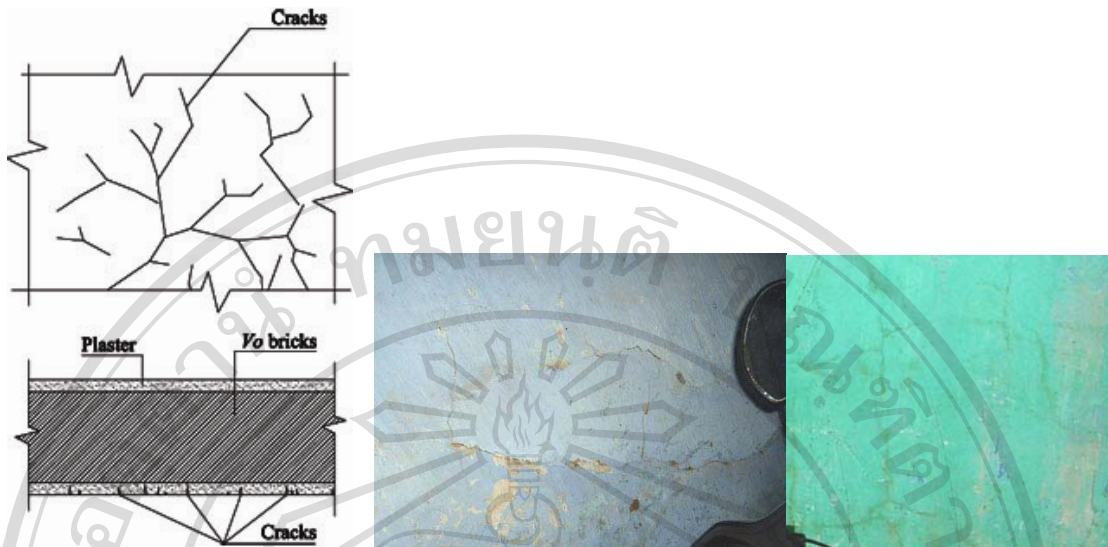
core of the walls made of bricks has lower Thermal Expansion Coefficient than the outer plaster made of lime mortar (Fig.3.26), which consequently cause the thermal movement of brick lower than plaster when seasonal temperature changes. This uneven movement between those two adjacent layers has caused cracks in plaster of the walls, especially when the physical properties of mortar like the cohesion and elasticity of material in plaster are reduced by adverse climatic impacts. The cracks usually appear in the plaster layer (Fig.3.27). It does not affect directly to the structural strength of the walls but, indirectly, its openings allow water or moisture to penetrate into the bricks, the main structural materials for the load bearing walls, deteriorate them and lessen the strength of the walls. The accumulation of that phenomenon in the passing of time has widened old cracks and created new cracks which quicken the destructive process of the load bearing walls.

Fig.3.27 The cracks on the walls caused by uneven thermal movement between plaster and brick.

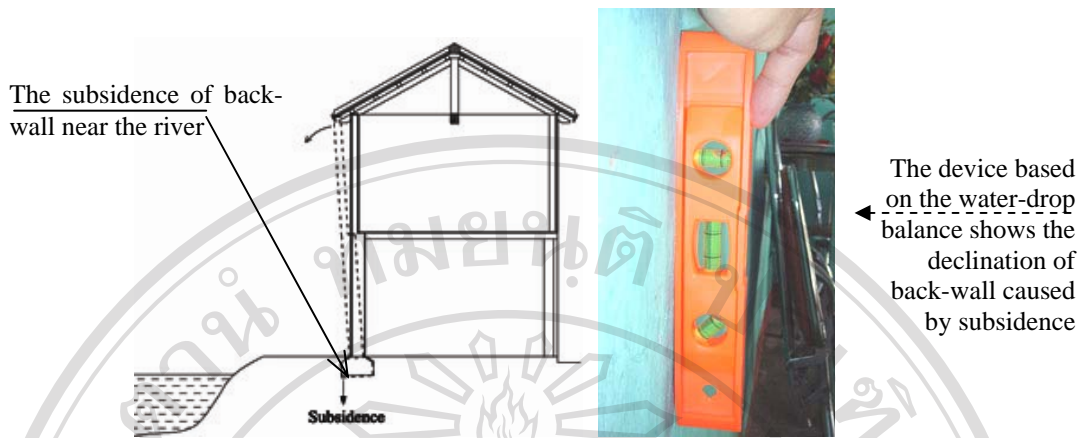
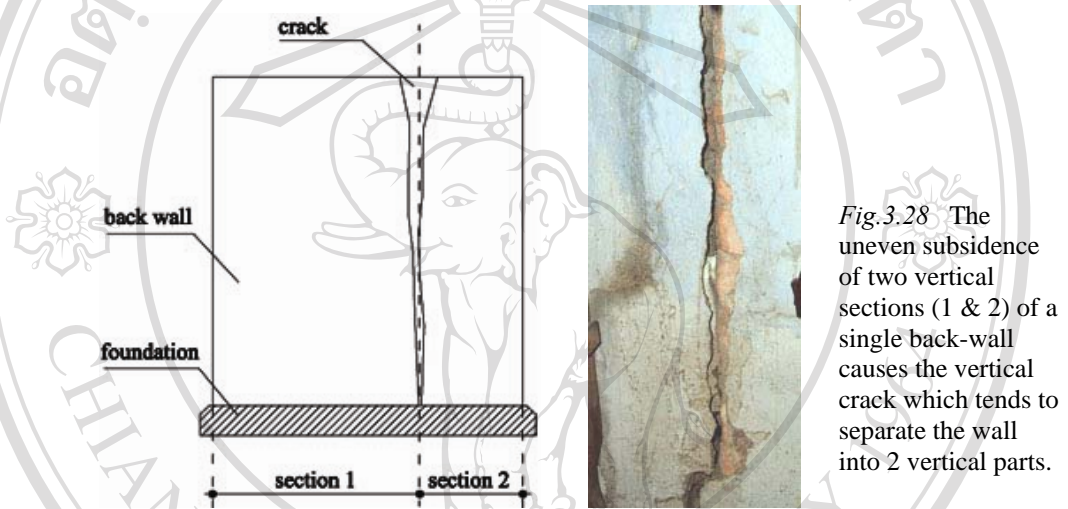
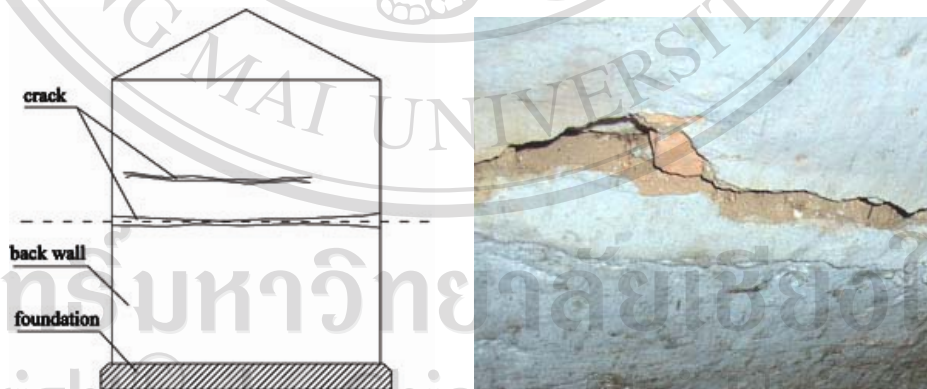
- The subsidence of *Tu Giac* houses, generally happened on the back side closely to the river (Fig.3.28), is the other cause of cracking in the load bearing walls. The extra weights added to the original *Tu Giac* houses by the later spatial expansions have led to the subsidence of their footings. The load bearing walls placed directly on them are moved out of their initial positions. This happening has created the shear and tension forces apart from the only compression forces the walls have to withstand. As a consequence, cracks have been created on the walls in both the plaster and the bricks. The cracks caused by the subsidence usually tend to separate the wall into many pieces. They are much wider and deeper than by thermal movement (Fig.3.28& 3.29). They are more harmful to the house because they affects directly to the strength of the walls.

Fig.3.29 The subsidence of the whole foundation backwards creates shear forces in walls. It results in the horizontal cracks which are liable to divide the wall into 2 horizontal parts.

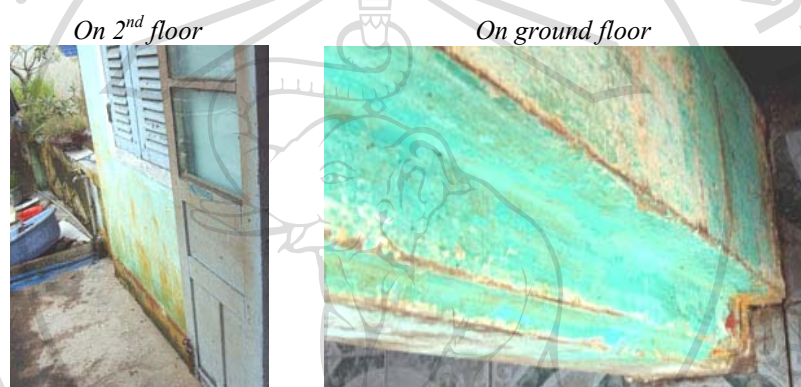
The lower parts of the walls on the ground floor soaked with annual floods with mud and dirt. The lower parts of the walls on the 2<sup>nd</sup> floor is wet by daily washing clothes are vulnerable to the growth of moss (Fig.3.30). It affects the physical properties of mortar in the plaster, reduces the adhesive nature of mortar and finishing material, and contributes, in other ways, to the deterioration process of the load bearing walls.

Fig.3.30 Moss appears on the lower parts of the load bearing walls on the 2<sup>nd</sup> floor (left side) and on the ground floor (right side).

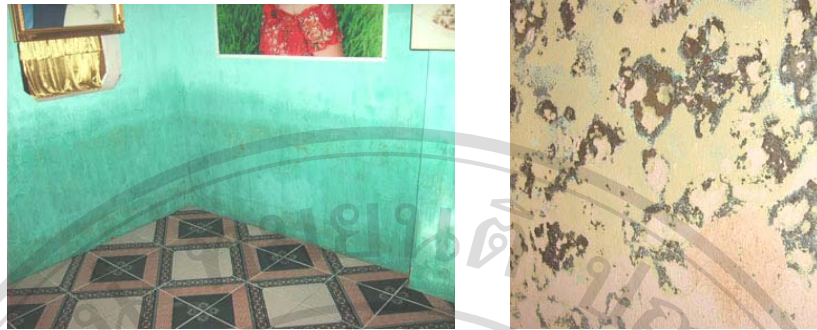
*Tu Giac* houses is the good condition for their rapid growth. Similar to moss, it has damaged the physical properties of mortar and then intensifies the destruction of the plaster in the load bearing walls (Fig.3.31).

Fig.3.31 Fungi and moulds have grown on the below part of the walls on the ground floor (left side) and on the 2<sup>nd</sup> floor (right side).

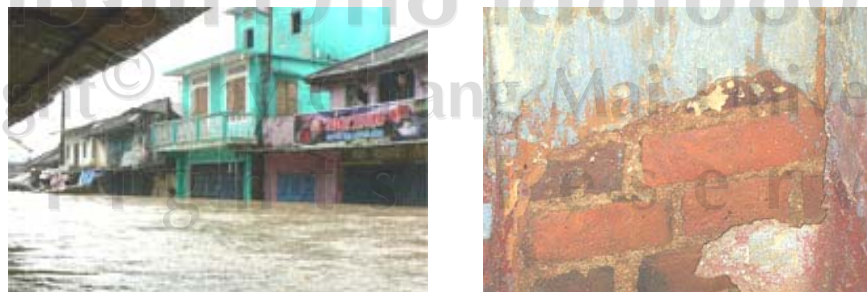
Fig.3.32 The flooding in Bao Vinh (in 2008) and the flakiness of the plaster and finishing on the below parts of the load bearing walls caused by flood.

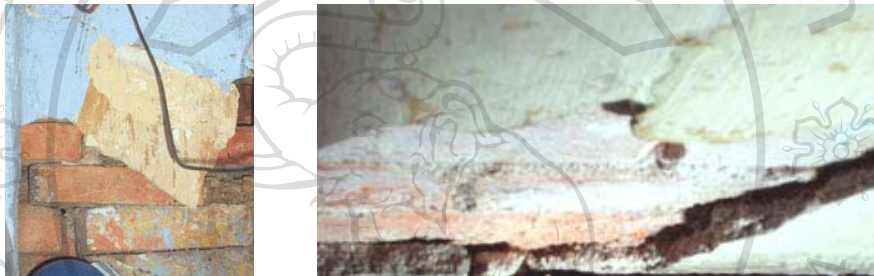
- The development of cracks has created the isolated regions of mortar which tend to fall down (Fig.3.33). The plaster and finishing are thus easy to be flaked off accordingly. In addition, the climatic impacts from high fluctuation of temperature and humidity of Hue weather have quickened the aging process of mortar. In time, mortar has been disintegrated and turned to powder before falling down. It also results in the flakiness of the plaster in load bearing walls.

*Fig.3.33* The flakiness of isolated regions of plaster caused by the development of cracks (left) and by the aging process of mortar (right) has made *Vo* bricks exposed to outside.

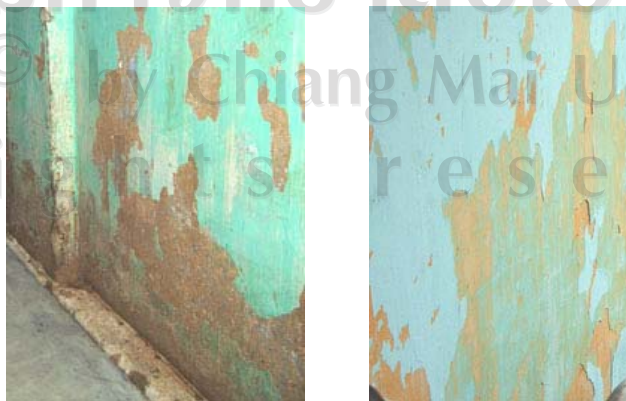
*Fig.3.34* The flakiness of finishing layers, the calcium-originated whitewash, on the load bearing walls.

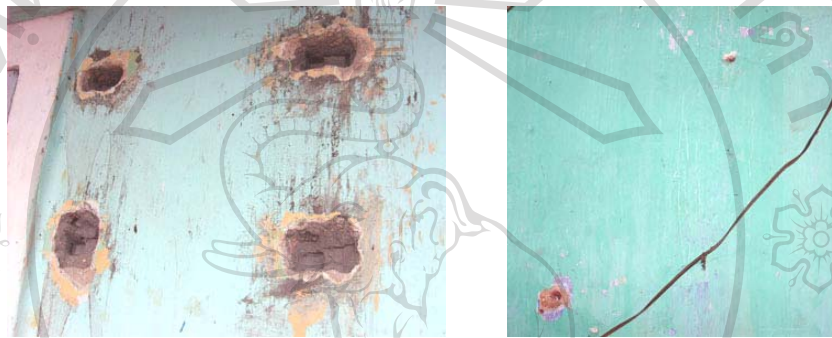
- The load bearing walls have been used for hanging things or objects by iron bars or nails. Drilling holes disorderedly on the walls for fixing them have damaged the surfaces of load bearing walls (Fig.3.35).

Fig.3.35 The holes created on the walls for hanging things or objects have been destroying the surfaces of the load bearing walls.

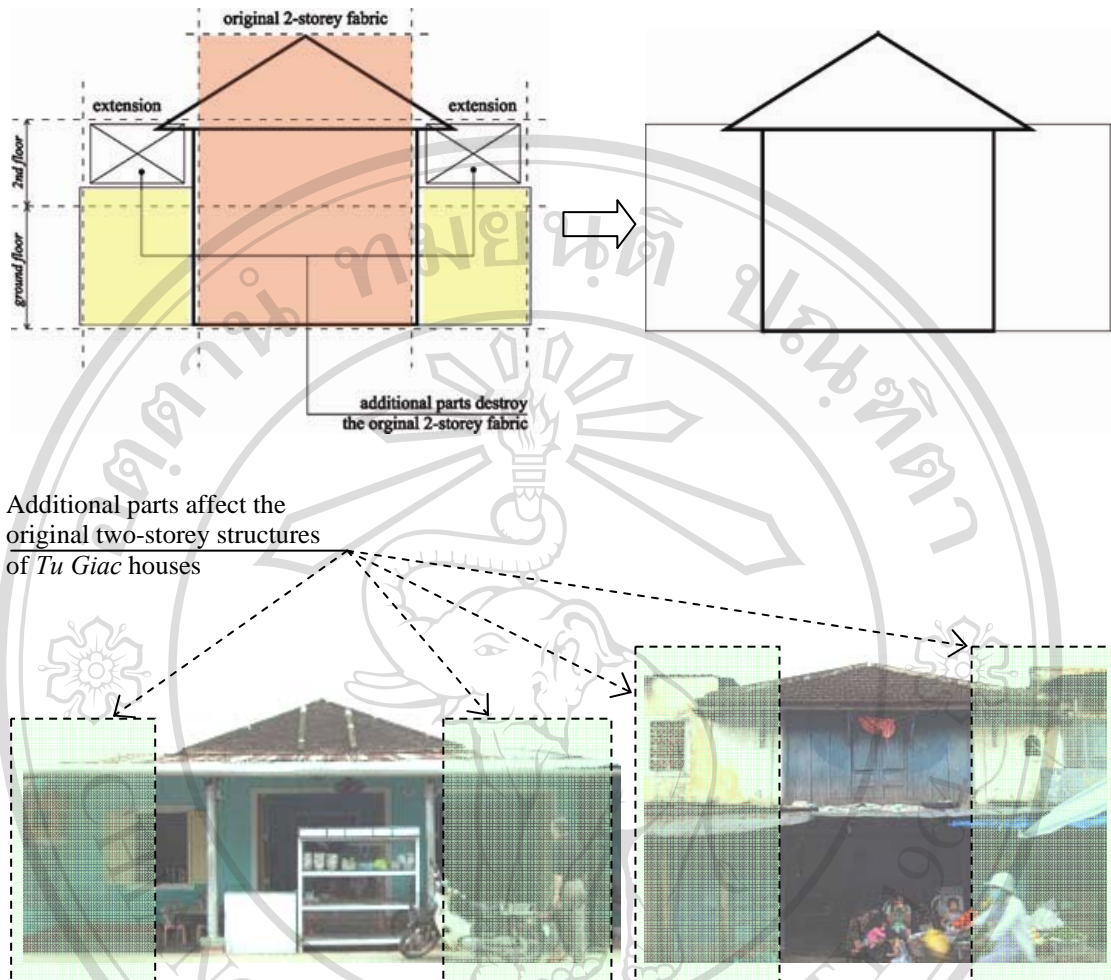
Fig.3.36 The additional parts on the 2<sup>nd</sup> floor conflicting with the hip roofs have destroyed the special scales in façades of the *Tu Giac* original two-storey fabric, shown clearly in the façade analysis (above) and the real photos (below).

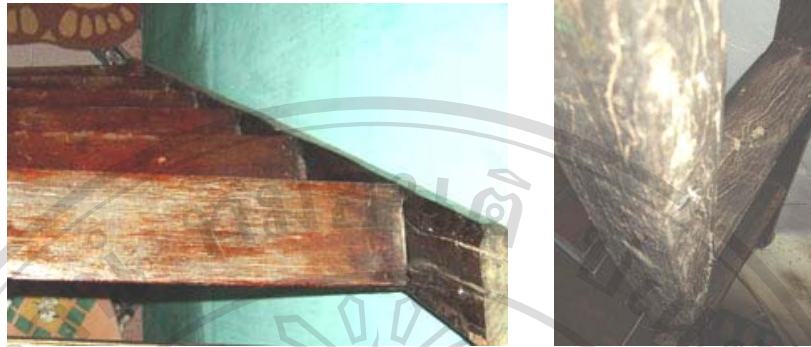
Cracks occurring on wood surface of the stair are induced by thermal movement. Wood is the anisotropic and not identical material that leads to the uneven expansion and contraction when seasonal temperature changes.<sup>15</sup> It has resulted in cracks on wood surfaces and contributed to the destruction process of high-pitch timber stairs (Fig.3.37).

*Fig.3.37* The cracks on the wood surface of the stairs caused by thermal movement.

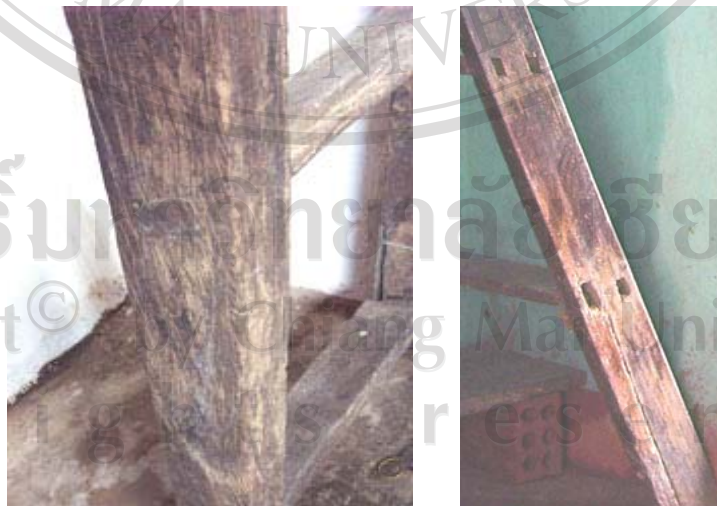
Wood is the organic material affected by time, especially under the impacts of temperature and humidity changes, the aging process of wood escalates and lead to the reduction of physical properties and the cohesion of wood material. The wood surfaces, which are contacting environmental changes, have turned to powder and been vulnerable to fungal and pest attacks (Fig.3.38). Through time, the timber elements of the stair have deteriorated and reduced the values of the high pitch timber stair.

*Fig.3.38* The aging process of wood and fungal attacks on their surfaces.

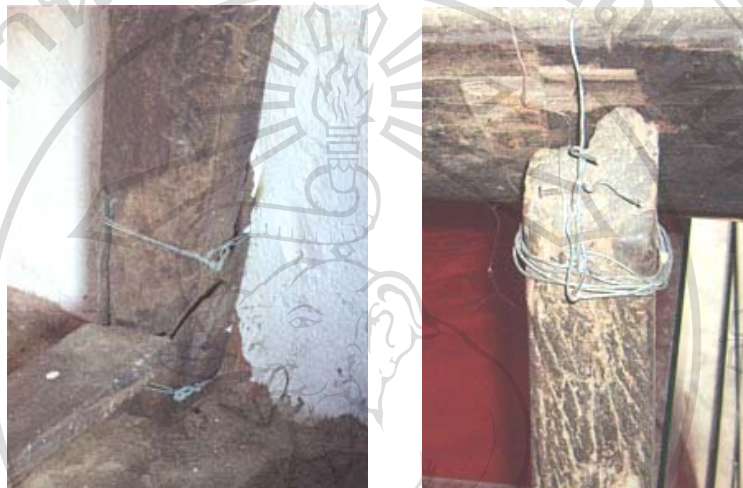
Due to located on the ground floor which suffers flooding every year, the ends of the high pitch timber stairs has been soaked into flood water for several days. Moisture, mud, and soil left on the below parts of them after flooding has destroyed the endpoints of the stairs and caused rots, cracks, or even broken (Fig.3.39).

Fig.3.39 The damaged endpoints of the stairs.

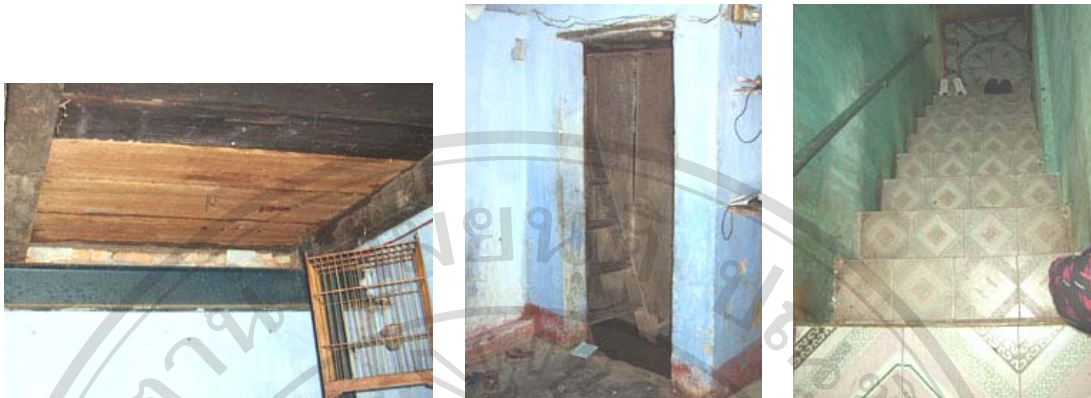
Fig.3.40 The moving to the other place outside the original structure of *Tu Giac* house and its stair hole left with the new wooden planks (2 photos on left sides). The changing into new material of concrete of the timber stair (right side).

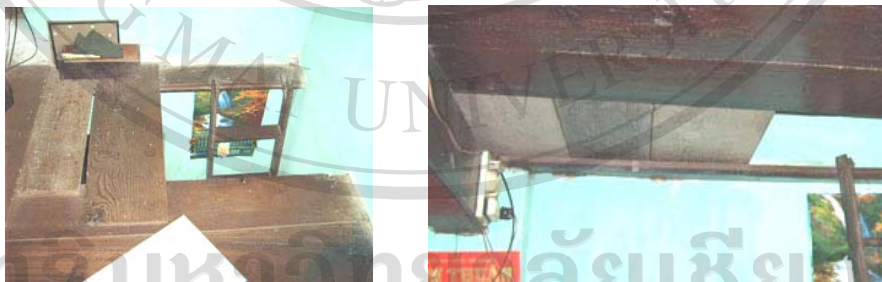
Fig.3.41 The encroachment of the stair-holes by disordered wooden planks has affected the outstanding characteristic of the timber stair.

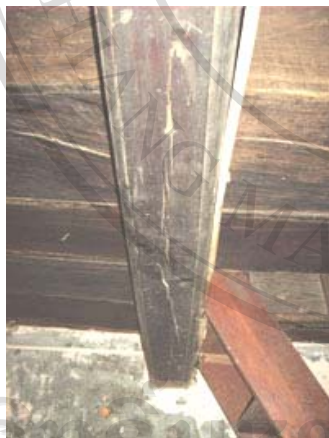
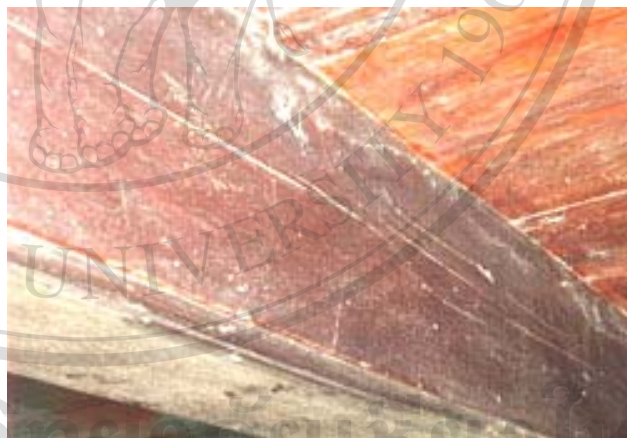
Cracks occurring on the timber planks and beams of the 2<sup>nd</sup> floor are caused by two reasons: thermal movement and the reduction of strength (Fig.3.43 & 3.44). The uneven expansion and contraction of wood induced by seasonal temperature changes

is liable to cracks on the wooden surfaces of floor beams and planks. Through time, the physical properties and the cohesion of wood to withstand compression and tension stresses are reduced gradually. It makes the elements of the timber floor weaker and results in the cracks on them.

*Fig.3.43* The structural cracks along the below half of the floor beams caused by their weakness in withstanding the tension stresses.

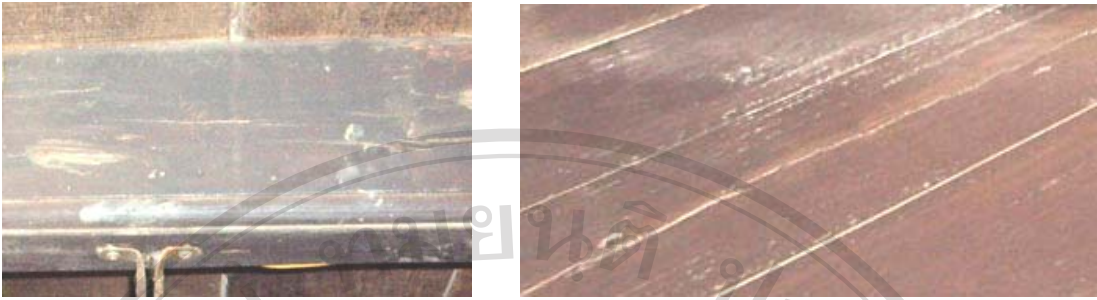
Fig.3.44 Cracks appeared on the wooden surfaces of the floor beam (left) and planks (right) caused by thermal movement.

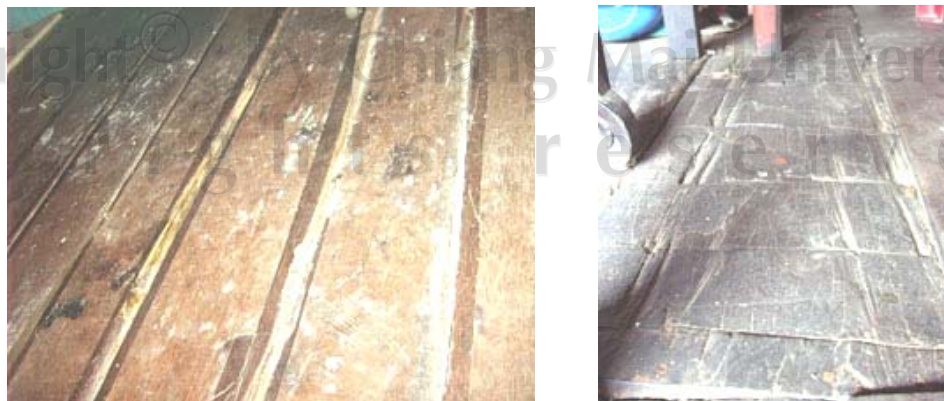
Due to suffering flooding on the ground floor every year, some original timber planks of the 2<sup>nd</sup> floor have been removed to enlarge the access hole for moving big objects or goods upstairs (Fig.3.45). To assemble or disassemble them easily and quickly, the new timber planks without *groove and tongue* joints have been used as the substitutes. It leads to the looseness among those new planks and enable dusts to fall downstairs through the open slits in between. To avoid this problem, some owners have utilized sticking-plasters to close the slits. In addition, the poor-quality planks are used for changing the original ones. All the above things have disfigured and affected seriously the outstanding characteristics of the original 2<sup>nd</sup> floor in *Tu Giac* houses.

Fig.3.45 The poor-quality planks used as the substitutes for the original ones with the covering of sticking-plasters on opening slits in between (left).

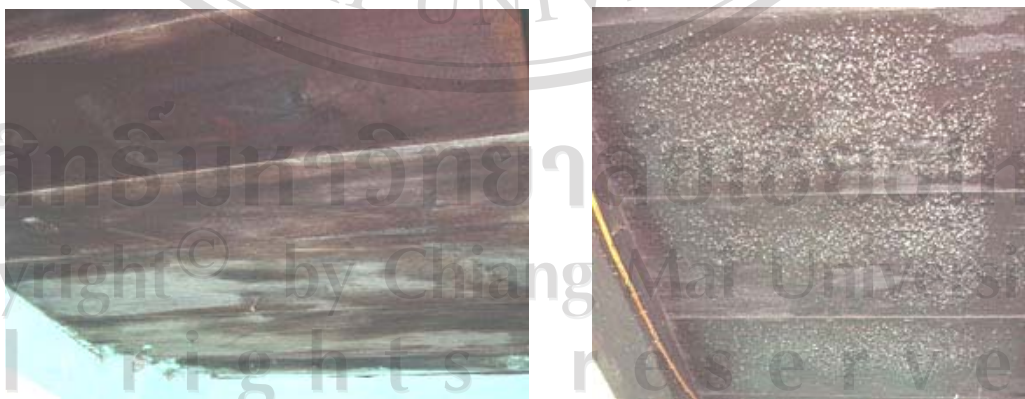
- The attack of fungi in the 2<sup>nd</sup> timber floor can be detected by the whitish discoloration of wood and by, through paintwork, the whitish flecks on the darker background (Fig.3.46). These kinds of fungi can destroy the lignin<sup>17</sup> of wooden planks and beams. The wooden planks and beams that are embedded in masonry like load bearing walls of *Tu Giac* houses have high moisture content and thus are destroyed by fungi. The wood-staining fungi grow on wood surface and produce stains. It induces the flakiness of painted surfaces.

Fig.3.46 Fungal attacks with white flecks on the wooden surfaces of the floor planks.

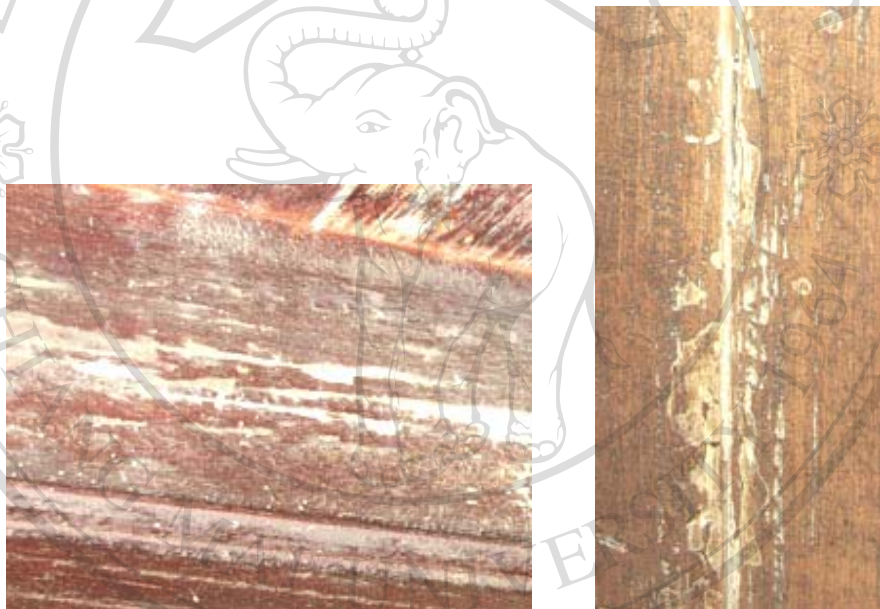
Fig.3.47 Floor beams and planks are attacked by termites.

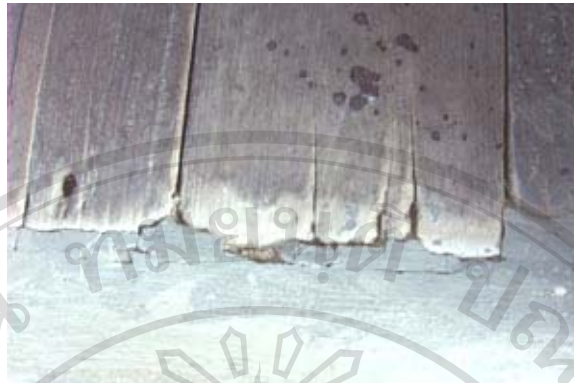
The endpoints of the timber floor planks which are enclosed in masonry walls are threatened by rot and termites due to the high moisture content inside walls. It increases the deterioration process of their endpoints (Fig.3.48).

*Fig.3.48* Deterioration of the endpoints of the timber floor planks.

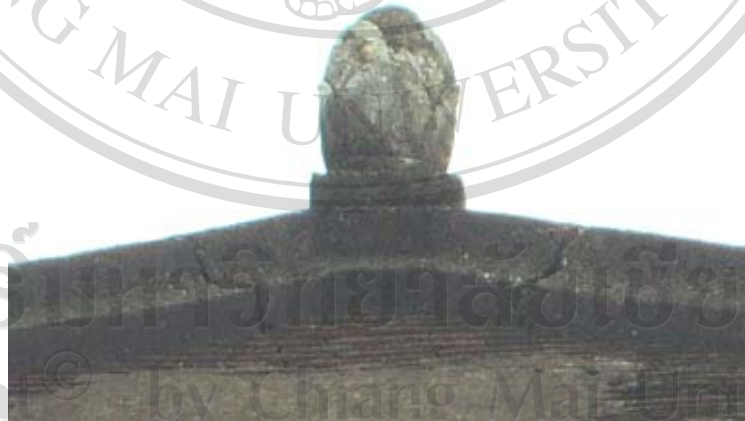
At the positions of the roof ridges 30-50cm from the peak, the only connection of four ridges, cracks normally happen due to their tendency of sliding down. It creates openings on the top liable to water-leaking inside the houses (Fig.3.49).

*Fig.3.49* The cracks of the roof ridges on the top.

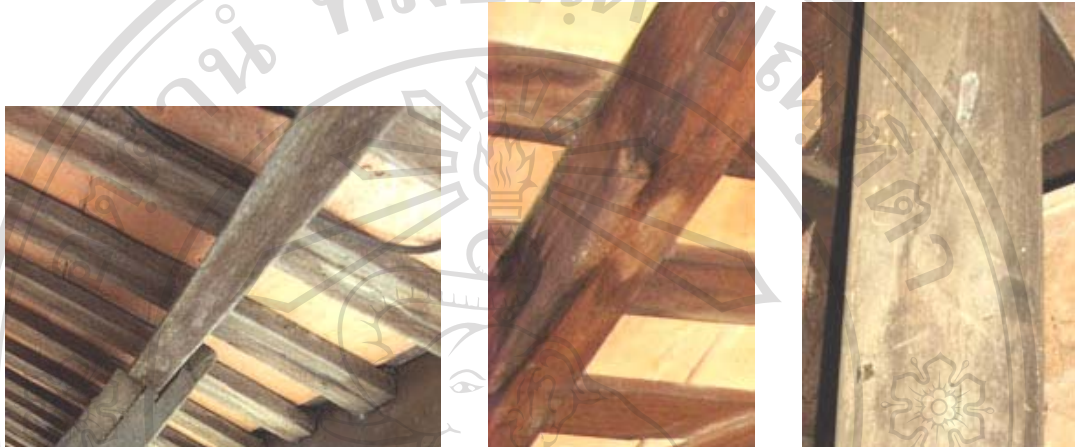
especially the dry-wood termites. In addition, the rain-water penetration from the top through decayed *Liet* tiles has increased the growth of them and deteriorated the timber frame system. It also contributes to the aging process of wood (Fig.3.50).

*Fig.3.50* Fungal attacks (left and middle) and termite attacks (right) on the elements of the timber frame system of hip roof.

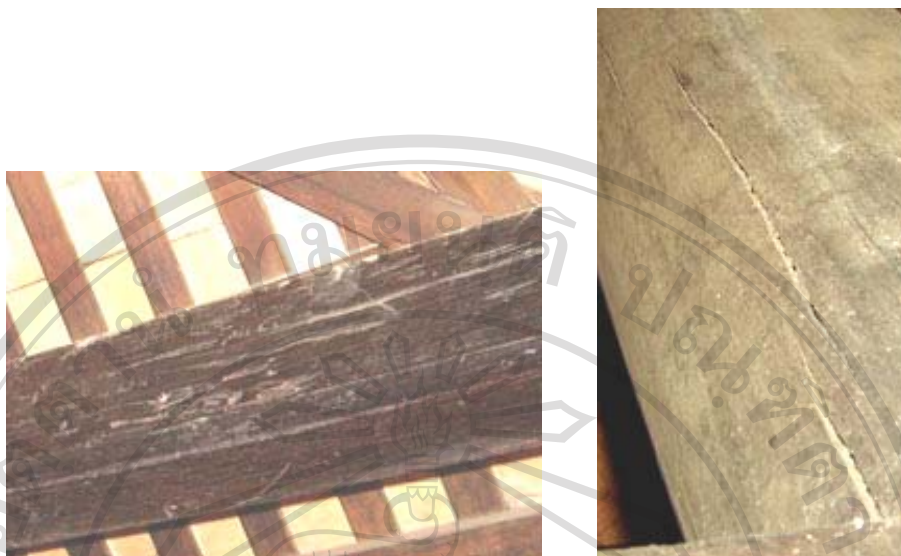
Similar to the timber stair and 2<sup>nd</sup> floor, thermal movement occurring inside wood has caused cracks on the wood surfaces of the elements of timber frame system of the hip roof (Fig.3.51).

Fig.3.51 Cracks caused by thermal movement appear on the horizontal (left) and vertical trusses (right) of the timber frame system.

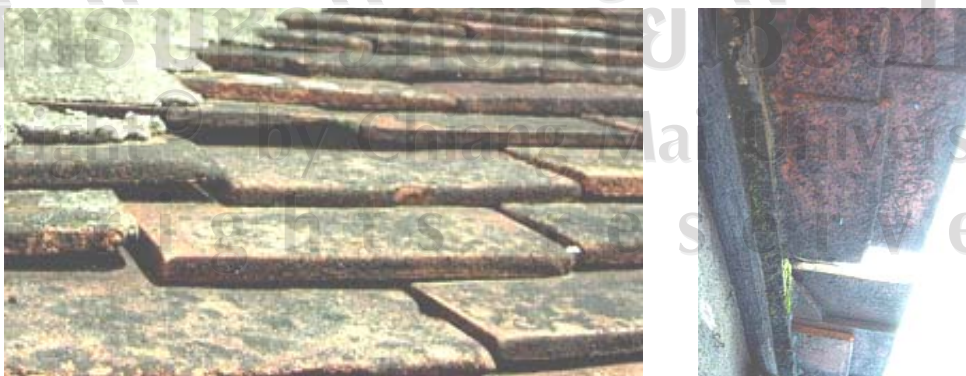
Fig.3.52 Mosses grow on the top surfaces of *Liet* tiles.

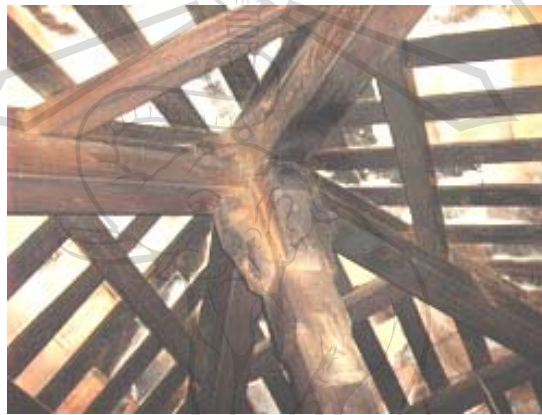
Fig.3.53 Mould and fungi on the surfaces of *Liet* tiles due to high moisture content inside the house.

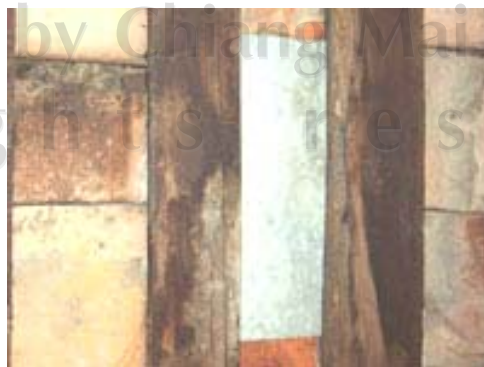
Fig.3.54 Iron plate is used to seal the holes on the roof for water-proof.

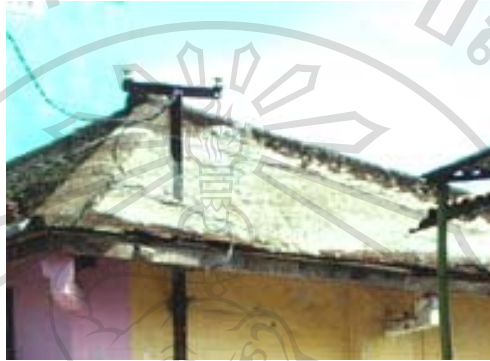
Fig.3.55 The filling of mortar on the roof to prevent water-penetration.

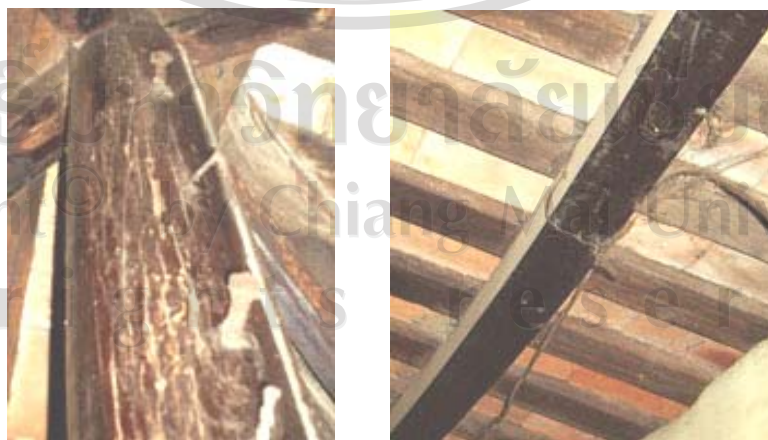
Fig.3.56 Iron nails fixed on timber elements cause rots of them.

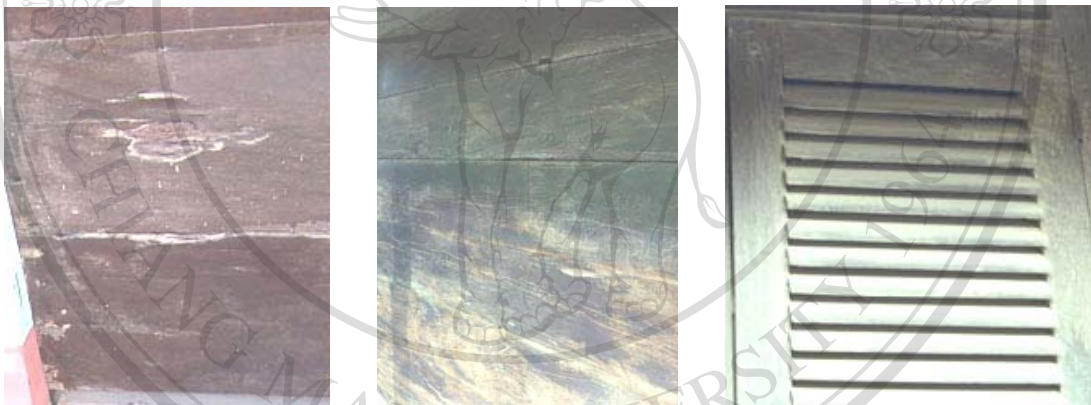
Fig.3.57 Holes, cracks and rottenness are created on the surfaces of wooden doors and windows by pest and fungal attacks and the aging process of wood.
