## Chapter 3

### Methodology

#### - Descriptive Analysis to define the Historical Values and Outstanding Architectural Characteristics of *Tu Giac* Houses -

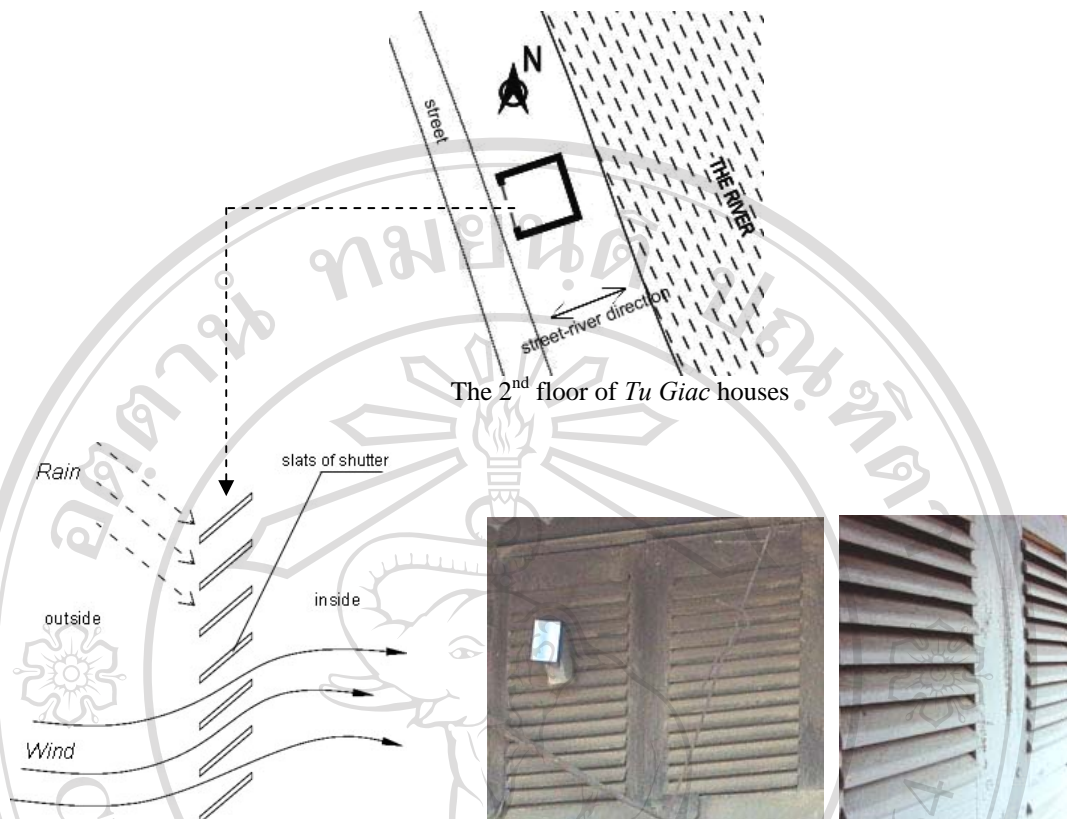
Fig.3.23 The shutter windows with its response to hot and humid climate are used for the 2<sup>nd</sup> floor spaces of the *Tu Giac* houses.

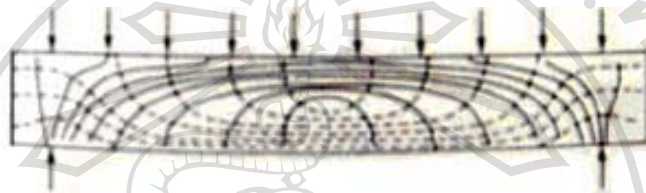
Cracks occurring on the timber planks and beams of the 2<sup>nd</sup> floor are caused by two reasons: thermal movement and the reduction of strength (Fig.3.43 & 3.44). The uneven expansion and contraction of wood induced by seasonal temperature changes

is liable to cracks on the wooden surfaces of floor beams and planks. Through time, the physical properties and the cohesion of wood to withstand compression and tension stresses are reduced gradually. It makes the elements of the timber floor weaker and results in the cracks on them.

*Fig.3.42* Isostatics are contour lines of tension (*dotted lines*) and compression (*solid lines*). The intersection of lines shows shear. The closeness of the contours expresses the intensity of stress. It indicates that tension is greatest at the bottom and compression is biggest on the top of the beam at mid-span. Shear is greatest at the ends<sup>16</sup>. It accounts for the appearance of cracks along the below half of the beam due to excessive tensions.
